PC Sludge Pump Operates 8 Years & 26,000 Hours Without Repair

The device could have run longer had wastewater treatment plant not decided to upgrade.

Technicians recently received and disassembled a progressing cavity (PC) sludge pump that fed centrifuges in a wastewater treatment plant for eight years without repair.

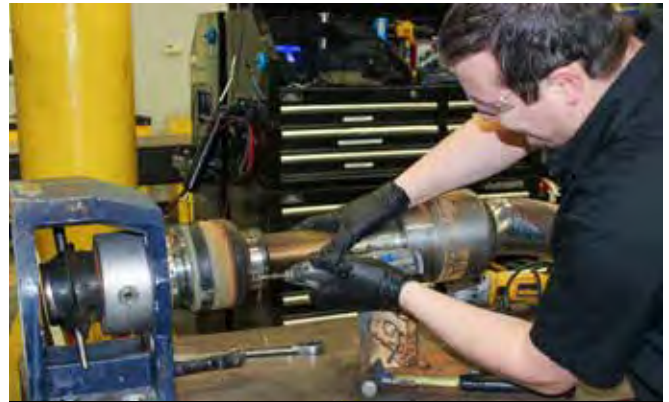
Image 1. Tight manufacturing ensures a longer life for the pump. (Images courtesy of SEEPEX Inc.)

This joint was constructed from just a few wear resistant, hardened and exchangeable components. It is fastened by means of a retaining sleeve on the rotor head, the plug-in shaft head or the drive shaft head. Tight manufacturing tolerances ensured that the pump ran quietly and smoothly.

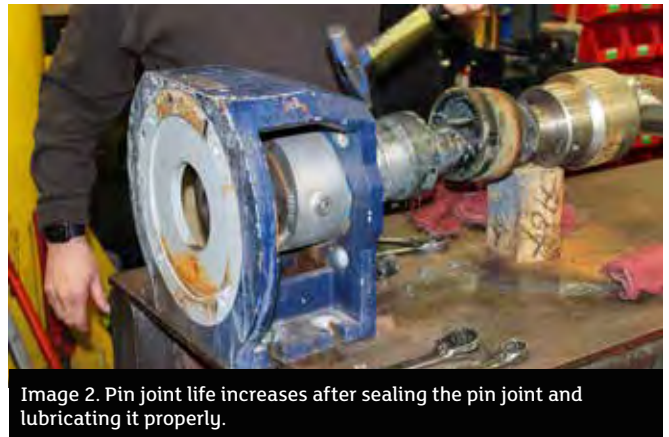
Image 2. Pin joint life increases after sealing the pin joint and lubricating it properly.

Careful sealing of the pin joint and proper lubrication increased life dramatically. The plug-in shaft pin was extracted, and it also exhibited normal wear. The pin changed color and showed polishing, but no real wear.
